Clearwater Township Fire Station & Township Hall

Building Condition Evaluation & Feasibility Study

February 2019

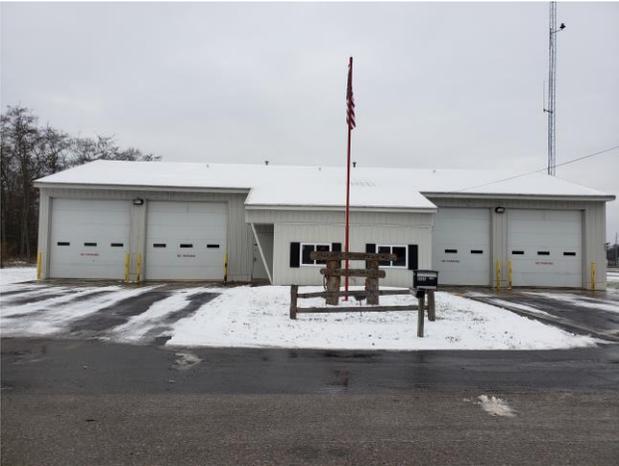
Fire Station

Station 5 is located on the southwest corner of Aarwood Road and Garfield Street in Rapid City. The original building appears to be about 40 years old and is a nominal 40' x 85' with a nominal 10' x 20' office on the east side of the building. The office, day room, kitchen, and restrooms are in a 20' section going across the middle of the building. There is a nominal 30' x 40' two-stall apparatus bay north of the dayroom, and another 35' x 40' two-stall apparatus bay to the south of the dayroom. Both bays discharge onto Garfield Road. In 1999, a nominal 40' x 32' addition was built on the south end of the west elevation. This expanded the south apparatus bay to have two addition stalls that discharge to the west. The associated drive also provided parking along the west side of the original building. The current building has a nominally 4900 SF footprint. There are storage rooms and mezzanines in both apparatus bays, which bring the overall building area over 5000 SF. The roof appears to be metal. No disrepair was observed or noted.

The facility is showing the wear and tear of several years of service and needs updating. In addition to refurbishing finishes, the facility is not A.D.A. accessible. The exterior doors have a 3-inch nominal raised wood threshold that not only prevents accessibility, but also is a tripping hazard that violates current building codes.

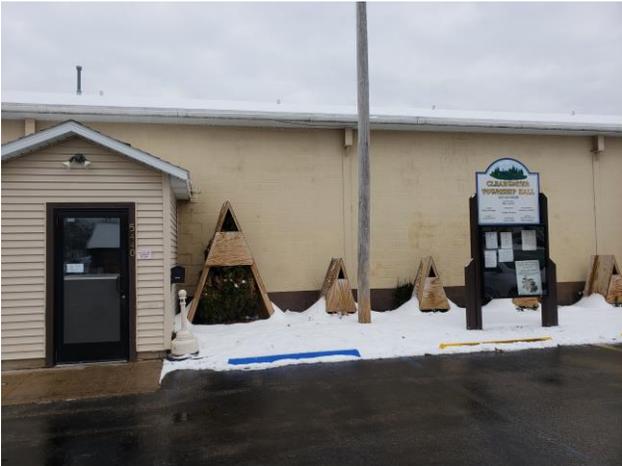
Township Hall

The existing township hall is a former elementary gymnasium building that has been repurposed to serve as the township office and meeting hall.

The building is nominally 102' x 69' (7040 SF) in size and approximately 14' high at the eaves with a 4/12 pitch roof. The structure is a pre-engineered metal frames at 20' O.C. with painted 8" concrete masonry units (block) between the columns. The roof appears to have single-ply membrane roofing. A small wood framed, vinyl sided vestibule is located at the south building entrance.

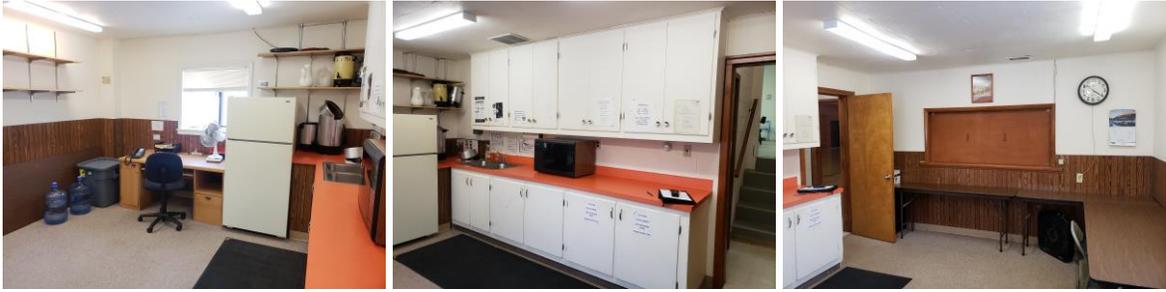
Kitchen:

- The kitchen is dated and in need of remodeling for warm-up and catering.
- Wall, floor and ceiling surfaces should be made to be easily cleaned.
- Casework should be replaced and reconfigured to wrap around the room to provide expanded work surface.
- A residential range is desired.
- The service counter opening needs to be remodeled to be A.D.A. accessible (counter height).

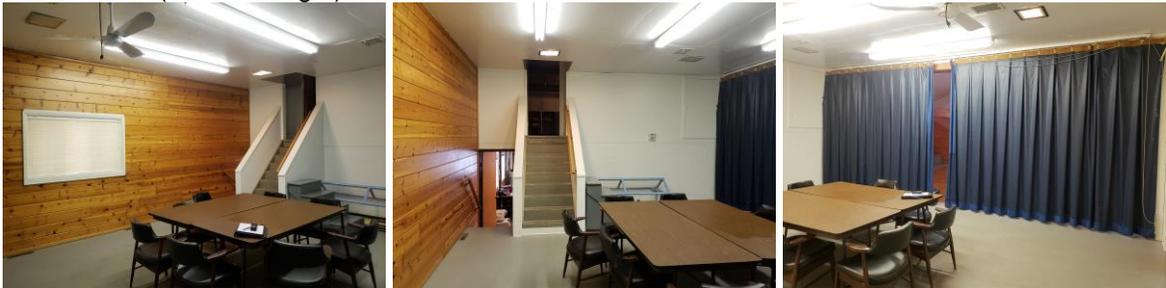
Stage:

- The stage is 23 FT wide, 18 FT deep, and 9.33 FT high with a hard ceiling. Stairs up from the office and up to the mezzanine take up approximately 6’ x 6’ of the northwest corner of the stage area.

- A stage curtain covers a 23’x9’ opening to the gymnasium.
- The stage level is approximately 3’-8” above the gymnasium floor.
- The stage is not A.D.A. accessible and it may not be technically feasible to make it accessible. The only practical location for a chair lift is in the existing office. However, there is not enough space at the stage’s north wall, with three sets of steps, from office to stage, stage to mezzanine over office (attic storage), and from the mezzanine above the office to the mezzanine above the stage (additional attic space).

- The lift would comply with code however, there is a liability concern with the fall hazard at the front edge of the stage.
- Should the building official require A.D.A. accessibility, it would be recommended to close off the stage opening and repurpose the space for storage; a function which would not be required to be accessible.

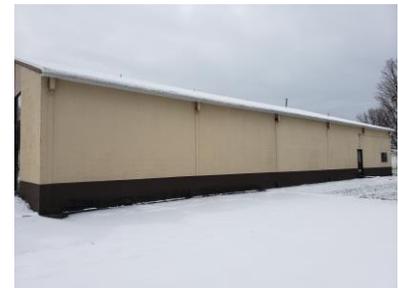
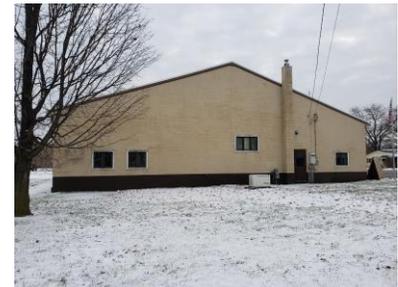
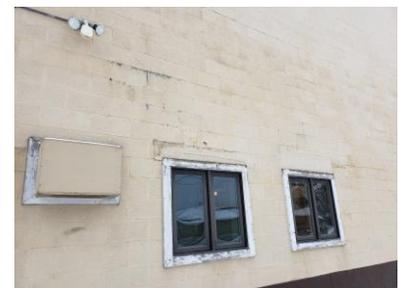
- **Exterior Walls:**
Water leaks at office windows were reported. Proper masonry flashing and weep holes were not evident in the masonry construction. Water that drains down the masonry cores is stopped at the lintels over the windows and is directed to the inside face of the wall. There are two options to address this situation:

- The less costly and less reliable method would be to tuck-point cracked mortar joints and paint the entire exterior walls with a sealing paint. While this will solve the problem in the short term, new cracks in mortar joints will occur, and the walls will need repainting.

- While costing more, a more reliable method would be to cover the exterior walls with metal siding. With proper flashing, the siding would prevent rain water from contacting the masonry. Other types of siding could be used, they tend to cost even more.

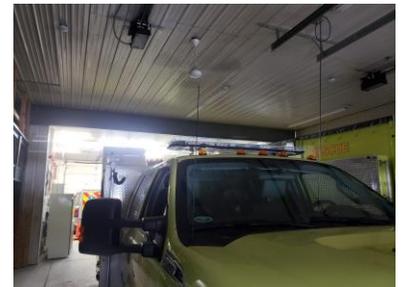
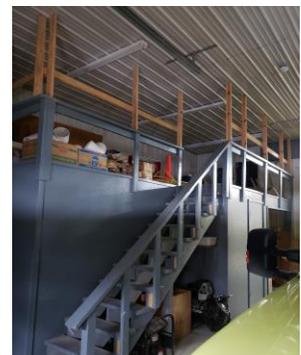
Existing Southeast Apparatus Bay:

- Lower threshold of existing exterior man door to eliminate tripping hazard.
- Provide additional exhaust ventilation for vehicle parking.
- There is insufficient space to provide a two-person office in this area as shown on the previous design drawings.

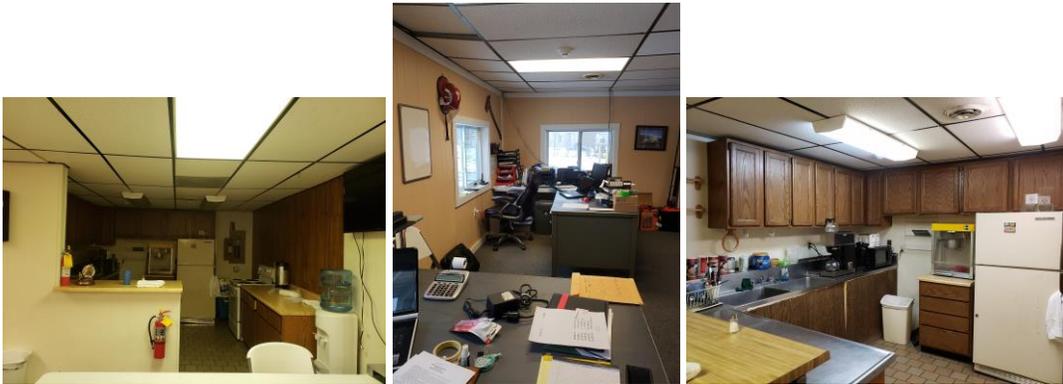
Dayroom and Staff Quarters:

The current staff quarters are not designed for 24-hour fire rescue services. The restrooms, day room and kitchen areas are worn, not barrier free, and do not provide sleeping quarters. There is no designated or extra space for fitness/exercises. There is no training room space. Renovation of the existing space for consideration to bring to current fire station standards are as follows:

- Divide and remodel existing offices into two dormitory rooms.
- Replace/update finishes in dayroom.
- Provide new pass-thru counter in north wall to proposed training room.
- Fully remodel kitchen with new cabinets, counters, equipment, and finishes.
- Fully remodel Men's restroom to be A.D.A. accessible with a shower. Relocate door to open from southeast apparatus bay. Function as a unisex decontamination shower room, that can also be used for daily needs.
- Remove service sink and water heater (these have been replaced in laundry).
- Expand Women's restroom into area vacated by service sink and water heater. Remodel to be an A.D.A. accessible unisex toilet with shower.
